Strong Rail-Post Connections for Wooden Decks

Where common connection details fail to meet code loads, prefab galvanized hold-down hardware passes the test

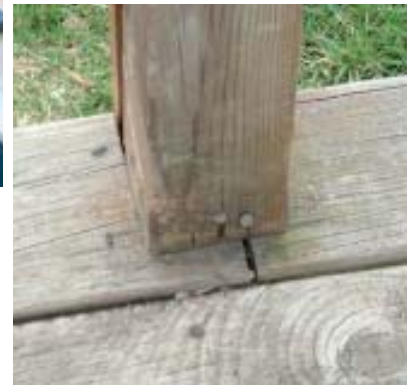
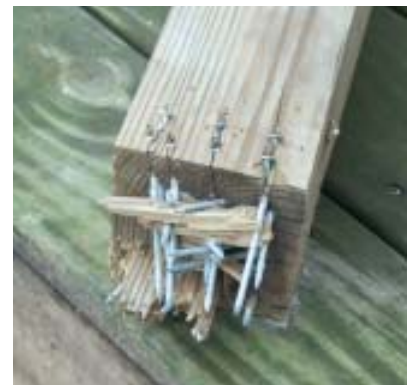
Researchers at Virginia Tech applied measured loads to deck posts to see which connections could meet code. The tests were spawned in part by one author's observations of dangerously weak details on existing decks, as in the two examples below, where railing posts were simply toenailed into the decking. The post in the bottom photo was covered by a decorative plastic cover, which concealed the flimsy connection.

The point was brought home to us when Frank was asked to inspect the railing on a friend's deck and found the rail posts toenailed into the decking (see photos on previous page), an unacceptably flimsy connection. Looking around our area of Virginia, we spotted other railing connections that made it clear that some deck builders, at least, aren't aware of code requirements for deck railings.

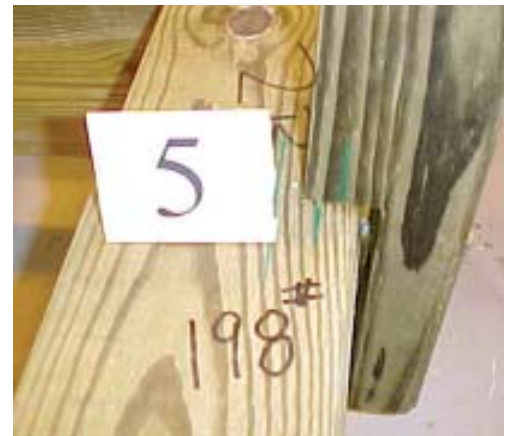
Figure 2. Although the bolted and lagged connections appeared sturdy, neither type could come close to meeting the target 500-pound test load, as the table shows. The authors tested five samples of each connection, applying a horizontal force at the top of the post until the post detached from the joist structure or the band joist itself came off. A piece of 5/4 decking nailed to the simulated joists and band joist did little to prevent failure.

The lag-screwed connection failed at less than 200 pounds when the lags pulled out of the band joist. The bolted connections failed at an average load of 237 pounds — barely surpassing the code design load but with almost no safety factor for the service life of the deck. The bolted samples typically failed when the band joist peeled away from the deck joists, as the screws attaching the band to the joists pulled out. The screws holding the 5/4 deck

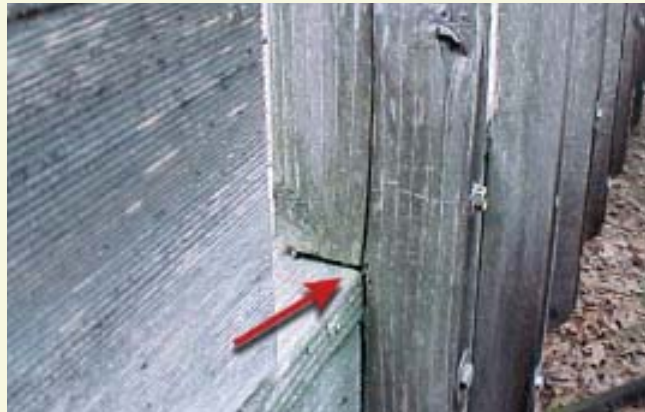
Why Not Notch?

Cracks will typically develop from the corner of a notch (photo, right). As a crack develops, a steep “slope of grain” can critically reduce the section of the post, as the drawing shows.

Many years of observation have proved that moisture cycles will typically cause cracks to develop and propagate, parallel to the grain, from the corner of the notch. This may not be apparent when the post is first installed, but it happens gradually over time.

According to the grading rules for lumber, a piece of 4x4 No. 2 southern pine can have a “slope of grain” of up to 1:8 (or 1 inch in 8 inches). If a 4x4 with a slope of grain of 1:8 is notched 1.75 inches deep, a crack propagated along the grain will reduce the 1.75-inch-thick section at the notch to only $\frac{3}{4}$ inch at 8 inches above the corner of the notch — not something you’d want to bet your life on.

Several of the 4x4 posts we tested were notched around the band joist — a common detail in the field. While you might expect the notch to be the weak point in the connection, in fact none of the test posts failed at the notch. Even so, notching should be avoided, because it does substantially reduce the strength of the post. Here’s why:

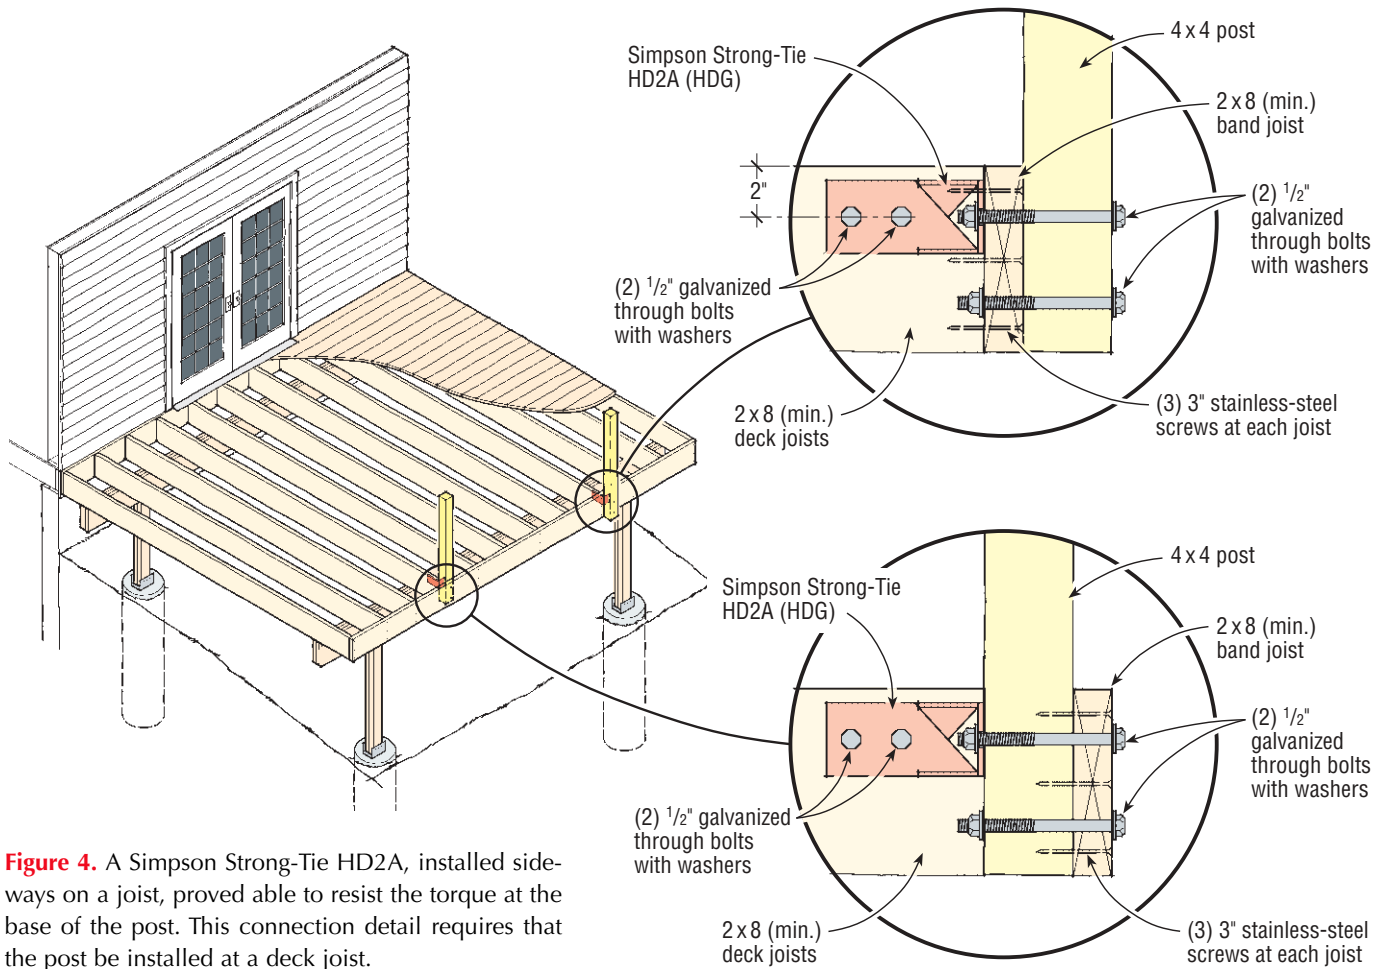
Figure 4. A Simpson Strong-Tie HD2A, installed sideways on a joist, proved able to resist the torque at the base of the post. This connection detail requires that the post be installed at a deck joist.

We turned to a commercial steel connector — a Simpson Strong-Tie HD2A — which is designed to resist wind and earthquake loads in shear walls. By orienting the connector sideways along the joist, we were able to use it to secure the post (Figure 4). We installed the HD2A with three 1/2-inch-diameter bolts: The two bolts in the third bolt, passing through the post, the band, and the connector itself, is loaded in tension. As part of the tested design, we also installed another 1/2-

We used only one Simpson HD2A per post, placing the centerline of the connector 2 inches below the top edge of the 2x8 joist. If you use this detail in the field, it's important to maintain this centerline distance, because it helps to limit the forces involved in the connection. If you place the HD2A lower, you're reducing the resisting lever arm, which extends from the bottom of the band joist to the centerline of the connector. Losing even an inch of this resisting lever arm would greatly increase the forces in the connector.

We used a hot-dipped galvanized (HDG) HD2A connector for our tests. Because of the corrosive nature of the new lumber treatments, this is the version that should be used in practice.
