Strong Rail-Post Connections for Wooden Decks

Where common connection details fail to meet code loads, prefab galvanized hold-down hardware passes the test

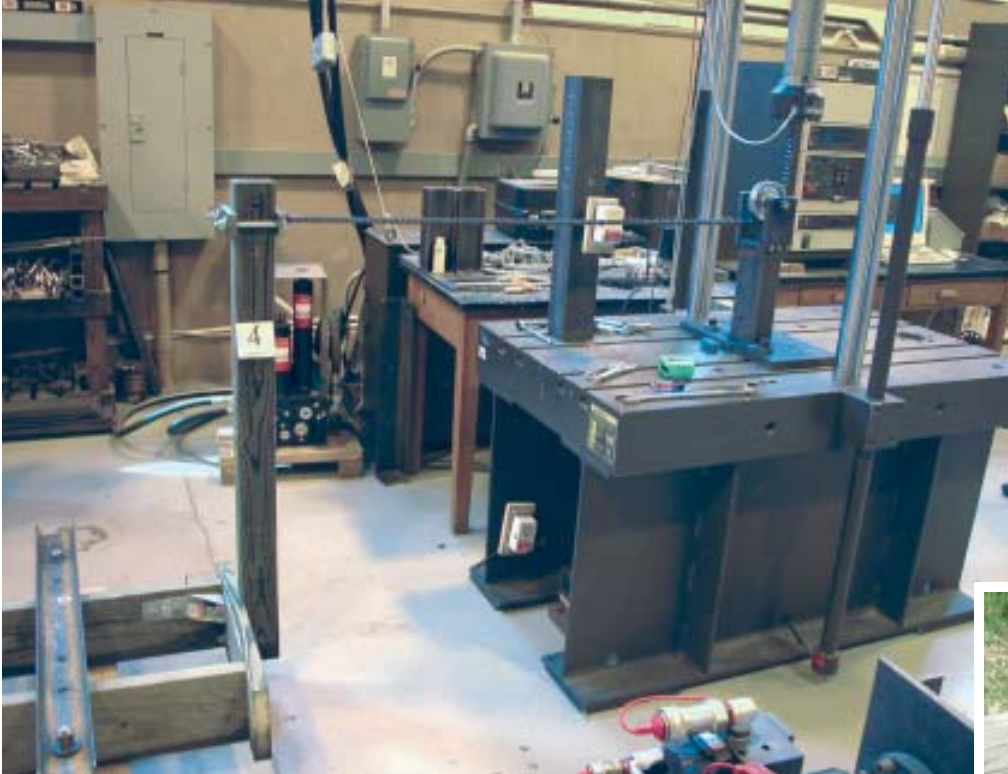
Researchers at Virginia Tech applied measured loads to deck posts to see which connections could meet code. The tests were spawned in part by one author's observations of dangerously weak details on existing decks, as in the two examples below, where railing posts were simply toenailed into the decking. The post in the bottom photo was covered by a decorative plastic cover, which concealed the flimsy connection.

The point was brought home to us when Frank was asked to inspect the railing on a friend's deck and found the rail posts toenailed into the decking (see photos on previous page), an unacceptably flimsy connection. Looking around our area of Virginia, we spotted other railing connections that made it clear that some deck builders, at least, aren't aware of code requirements for deck railings.
